LABORATORY TEST REPORT

Product Type: MgO Insulated Wall Panels w/ Brick Veneer	Series: ArmorWall w/ IQBrick
Project No.: MAX-001-02-02.01	Source: Max-Life Industries
Miami-Dade Notification: PRI1820527	Revision Date: June 26 th , 2018

Specimen 1: MgO Insulated Wall Panels w/ Brick Veneer (144"x96") on 20ga Steel Studs	
Test Method Description	Summary of Result
TAS 201-94 (Large Missile Impact):	Pass No Penetration

Specimens 2-4: MgO Insulated Wall Panels w/ Brick Veneer (48"x96") on 20ga Steel Studs	
Test Method Description	Summary of Result
TAS 202-94 (Avg Passing Neg Test Pressure):	-100 psf (-4800 Pa)

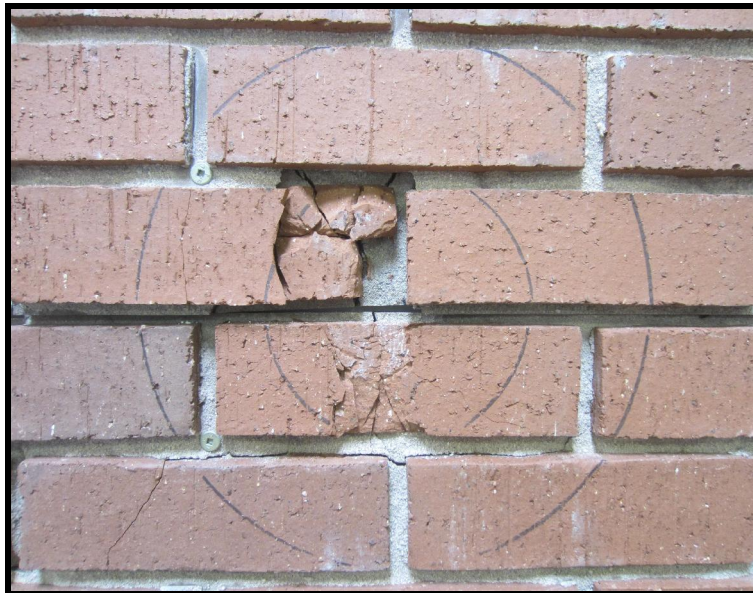
Typical Impact Result

Specimen 1: MgO Insulated Panel Wall Assembly w/ IQBrick (144"x96") on 20ga Steel Studs						
Impact ¹	Missile Weight	Missile Length	Missile Velocity	Location of Impact ²	Observation	Result ³
1	8.82 lbs (4000 g)	96" (2.4 m)	49.1 fps (15.0 m/s)	Midspan of Panel 1	Broke exterior brick, cracked interior insulation. No penetration.	Pass
2	8.82 lbs (4000 g)	96" (2.4 m)	50.2 fps (15.3 m/s)	Upper Left Corner of Panel 1	Broke exterior brick, cracked interior insulation. No penetration	Pass
3	8.82 lbs (4000 g)	96" (2.4 m)	50.0 fps (15.2 m/s)	Lower Right Corner Panel 2	Broke exterior brick, cracked interior insulation. No penetration	Pass
4	8.82 lbs (4000 g)	96" (2.4 m)	50.0 fps (15.2 m/s)	Midspan of Panel 2	Broke exterior brick, cracked interior insulation. No penetration	Pass
5	8.82 lbs (4000 g)	96" (2.4 m)	49.9 fps (15.2 m/s)	Upper Right Corner Panel 3	Broke exterior brick, cracked interior insulation. No penetration	Pass

6	8.82 lbs (4000 g)	96" (2.4 m)	50.9 fps (15.5 m/s)	Midspan of Panel 3	Broke exterior brick, cracked interior insulation. No penetration	Pass
7	8.82 lbs (4000 g)	96" (2.4 m)	50.3 fps (15.3 m/s)	Midspan of Panels 1 & 2 Intersection	Broke exterior brick, cracked interior insulation. No penetration	Pass

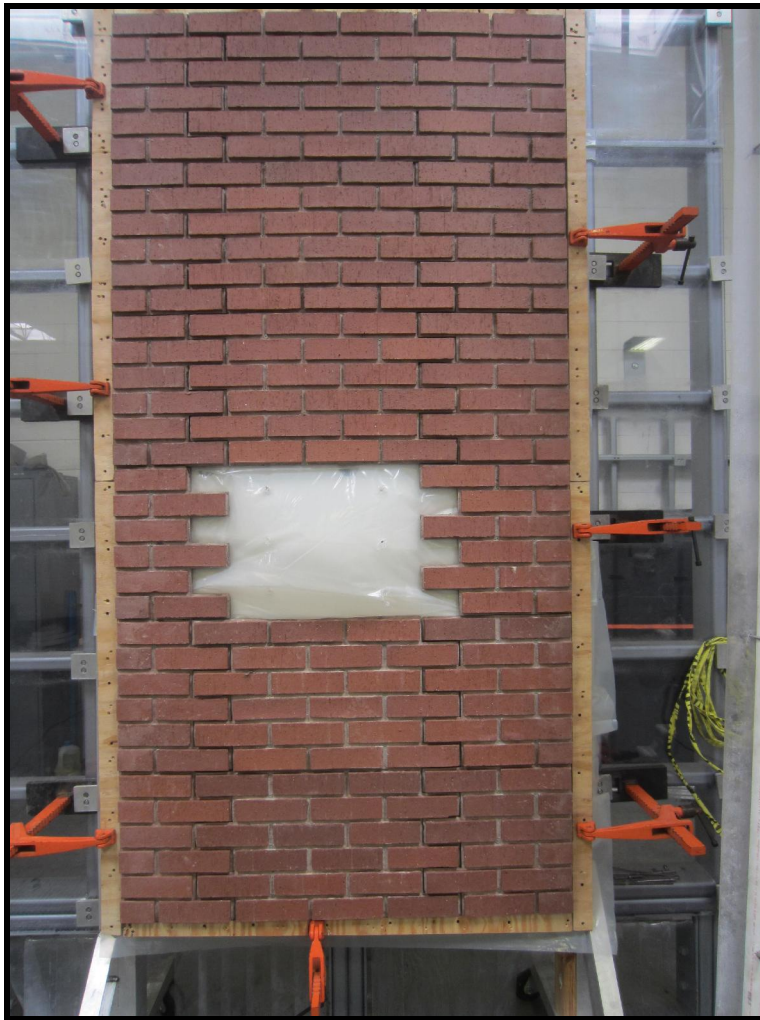
Specimens 2-4 TAS 202 Typical Failure

1. Polyethylene film and tape was utilized to seal for excessive air leakage.
2. Failure due to anchor withdraw from wall board.
